## **INSTALLATION RESTORATION PROGRAM**

# SITE INVESTIGATION REPORT

**VOLUME I – REPORT**

106TH RESCUE GROUP NEW YORK AIR NATIONAL GUARD WESTHAMPTON BEACH, NEW YORK FRANCIS S. GABRESKI AIRPORT

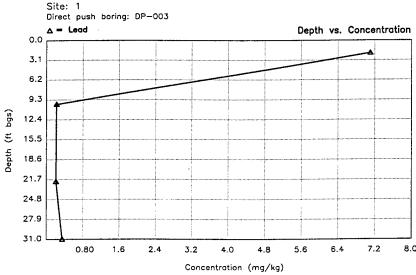
FIGURE 8-7
DEPTH VS. LEAD CONCENTRATIONS
SITE 1 - AVIATION GASOLINE SPILL SITE
106TH RESCUE GROUP, NYANG
WESTHAMPTON BEACH, NEW YORK

Subsurface Soils Lead was detected above reporting limits in eight of nine subsurface soil samples collected at this site (Figures 8-6 and 8-7). The concentration of lead does not exceed action levels in any subsurface soil sample. No other analytes were detected in these samples.

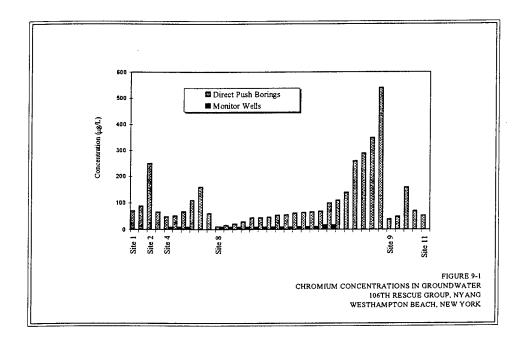
Chromium was the only analyte detected above reporting limits in groundwater samples collected from Site 1. The metal was detected above action levels in samples collected from two direct push borings. However, elevated concentrations of chromium in samples obtained from the direct push borings are not considered representative of groundwater quality at the facility.

Figure 9-1 shows chromium concentrations in groundwater samples collected from the direct push borings and wells. None of the samples collected from the wells contain chromium in excess of action levels. In contrast, many samples obtained from the borings exhibit concentrations greater than action levels and nearly all concentrations are significantly higher than those detected in the well samples. Groundwater from the direct push borings was collected by driving or pushing rods to the desired depth and retrieving a sample through a screen attached to the end of the leading rod. The samples were typically more turbid than those collected from the wells and it appears that chromium leached into solution upon preservation with nitric acid, thereby artificially increasing the dissolved phase material. The metal is naturally present in soils at this site (see Section 8.2.1 for background soil concentrations) and would be expected to dissolve during preservation when the pH of the sample is reduced to 2 (it is unlikely that chromium is mobilizing naturally because the pH of groundwater at the facility is approximately neutral). Conversely, the well samples did not contain visible particulate matter because the wells had been developed and purged prior to sample collection. Based on this, and lack of a known source of chromium at this site, the elevated concentrations detected in groundwater collected from the direct push borings are attributed to dissolution of naturally-occurring chromium from suspended solids during sample preservation and are not considered representative of actual groundwater quality.
